T-783
William S. Turner House
Bellevue
Private

Maryland Historical Trust State Historic Sites Inventory Form

Survey No. T-783

historic WILLIAM S. TURNER HOUSE

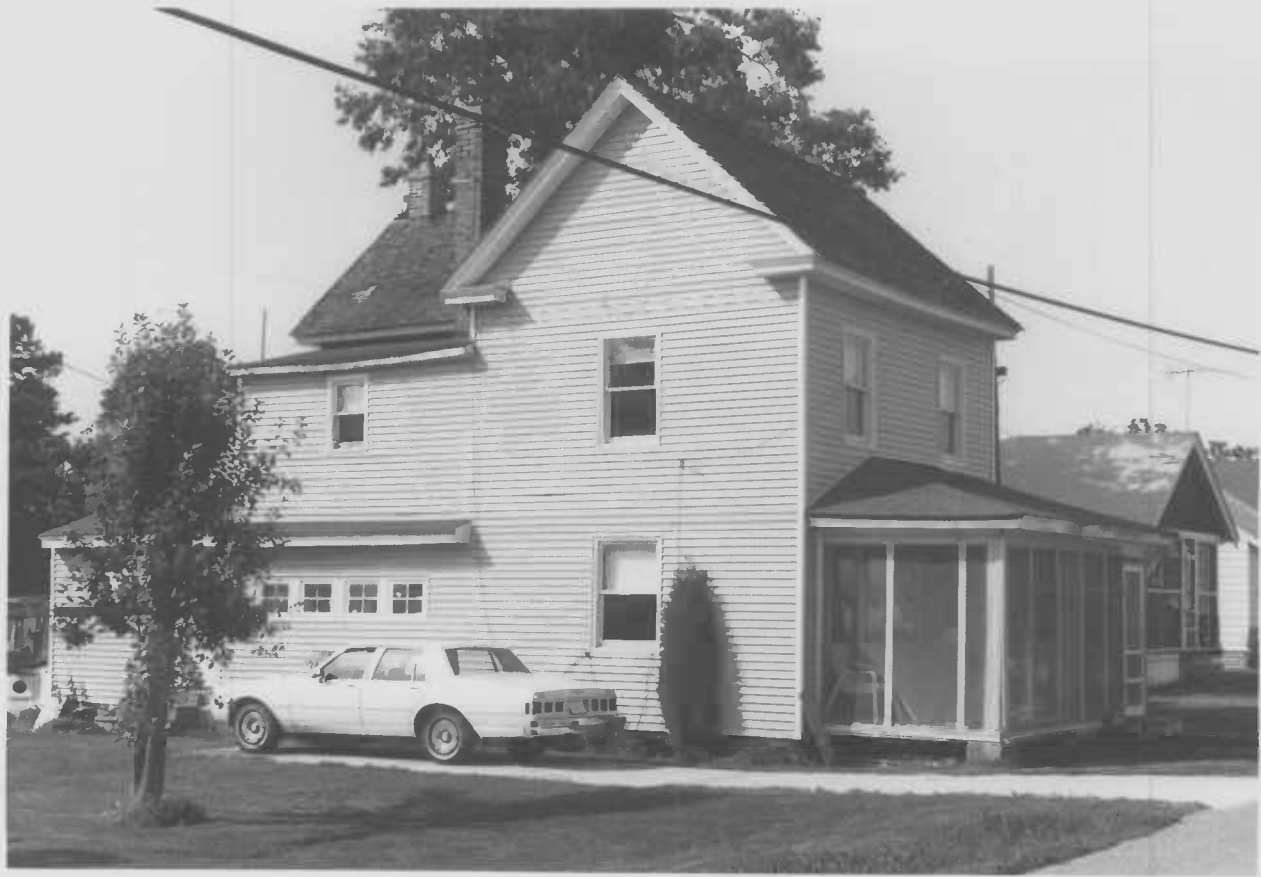
Southwest elevation

The northeast and southwest gable ends follow along similar finishes with single-pane sash windows lighting the first and second floors. A slightly extended eave is trimmed with short returns at the base of the roof. Rising against the northwest corner of the house, now within the shed addition, is a brick chimney stack.
